## AN INVESTIGATION ON ITZ MICROSTRUCTURE OF THE CONCRETE CONTAINING WASTE VEHICLE TIRE

### ABSTRACT

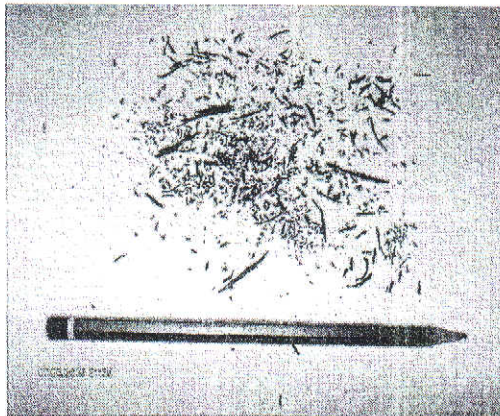
a) Tire fiber (0-4 mm)

**Figure 1.** Waste tire fibers used in this study.

Fiber shaped waste tire rubbers were produced by mechanical cutting. Cutting machine and shape of waste tire fibers are shown in Fig. 1. Waste tire fibers were divided in two groups by sieving. After the cutting processing, the waste tire fibers were sieved as 0-4 mm and 4-8 mm. Two groups of rubberized concrete mix were prepared.

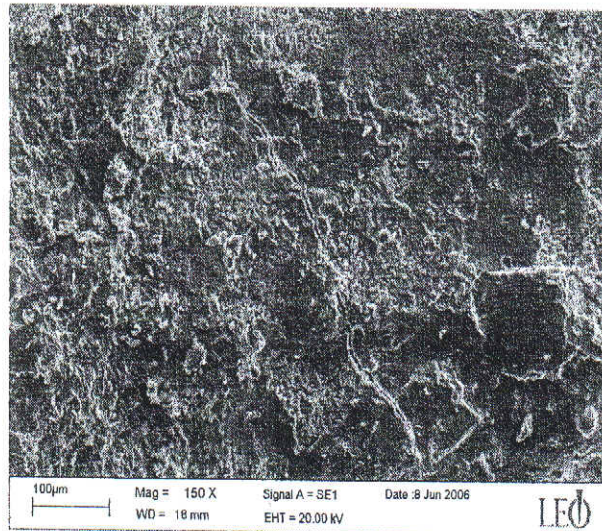
Figure 2. A SEM picture of fractured surface of control specimen.

The rubberized concrete has to confirm certain requirements for mechanical properties. They are particularly compressive and split tensile strengths. Although these values are considerably decrease with the addition of waste tire pieces as seen in Table 3, their values are still in reasonable range. After the concrete samples were selected for SEM studies, images were taken from each sample. A total of four samples taken from center and edge of the concrete cylinders in axial direction were studied. Fig. 2 shows the SEM image of normal concrete. It is clear that morphology of C-S-H gel appears as type III (denser-almost sphere) in the conventional concrete.

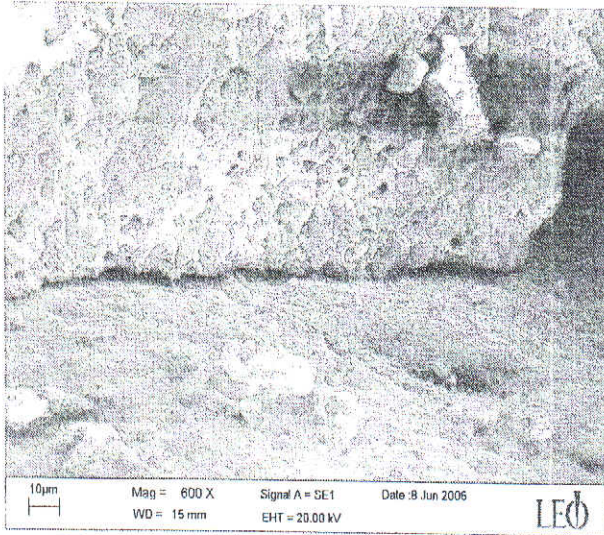
Figure 3. ITZ between rubber and cement

In the rubberized concrete, it is obvious that no interface bonding between cement paste and rubber tire has been maintained. An example of poor adhesion between them is shown in Figure 3. Without an interface bonding, stress transfer between fibers and cement paste is possible owing to a mechanical interlocking. Separation or breaking of the rubber was not oftenly observed on the fracture surface and generally the rubber appeared on the fracture surface was in the pulled out form. No transition layer, or even trace of patch of tire material adhering to the interface, was observed. This suggests that the interfacial bonding strength is weak. Figure 4 shows an example of pulled out a piece of rubber tire. As the rubber tires were

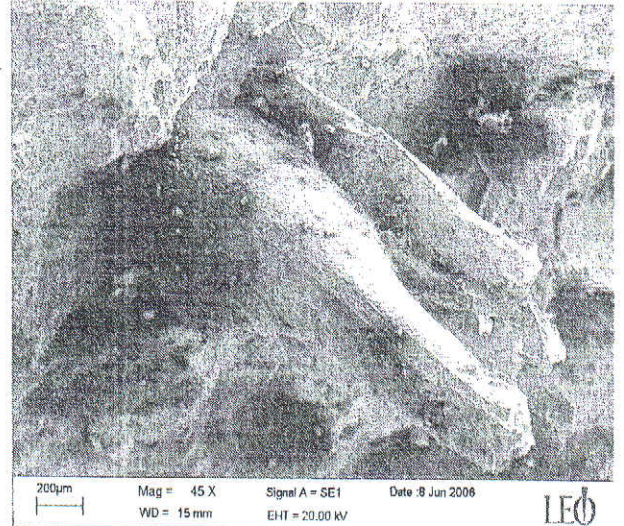
Figure 4. SEM image of pulled out rubber tire

being mixed, the hard particles of mix impacted and abraded the rubber surface as well as chopping procedure, causing deformation and so intrusions and extrusions. Grooves and pits also on the surface of the rubber tire fibers, due to its chopped form, the paste and rubber tightly matched. Therefore, strong mechanical interlocking has been established and no dramatic drop on the bending strength is recorded for a certain volume fraction of rubber tire.

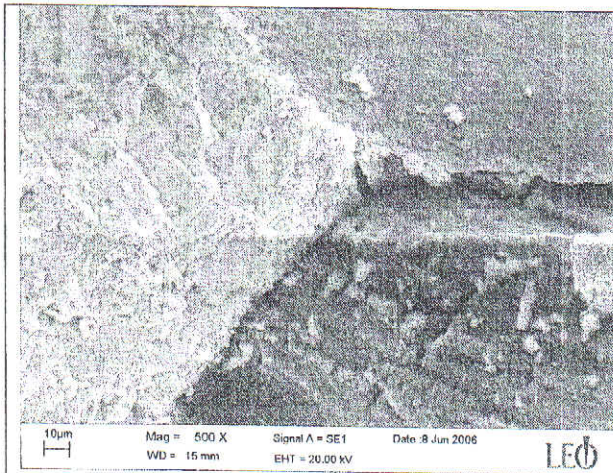
Figure 5. An image of ITZ between rubber tire, aggregate and cement paste

Interface structure of three components, cement paste and aggregate and rubber tire, is shown in Figure 5. A strong interface bonding between cement paste and aggregate is established but weak interface bonding between rubber tire and aggregate and cement paste is obvious from the picture.

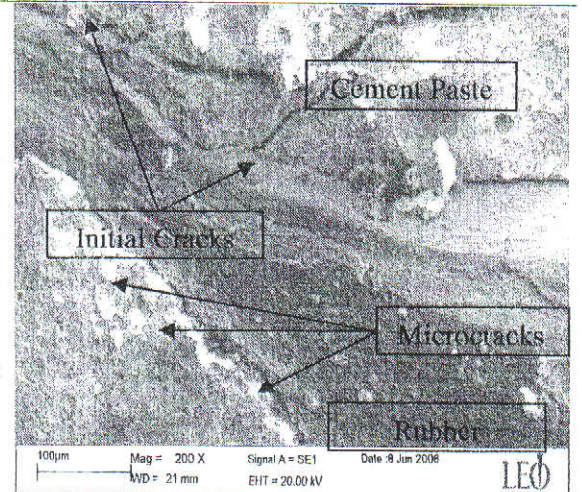
Figure 6. Scanning electron microscopy picture of rubberized concrete

The SEM images of rubberized concrete showed that cracks generated from voids between rubber tire and cement paste in the concrete. Fig. 6 and Fig 7 show some micrograph of microcracks generated from ITZ between rubber tires and cement paste. It was found that these cracks usually start from ITZ between rubber tires and cement paste because of poor bonding characteristic around rubber tires and cement paste. There are a lot of microcracks near ITZ in rubberized concrete. These microcracks seem clearly in Fig 6.
